Manhole Inspection Summary

Manhole # S21CC1016MH

Insp Date: **2/22/07 10:56 AM**

Location Address: **CLIPPER RD**

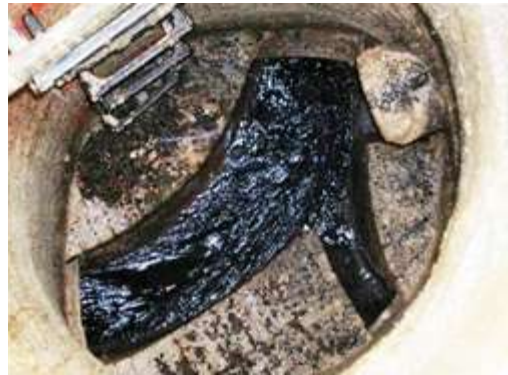
Top View

☒ **Debris** (not Condition related)

Bench debris.

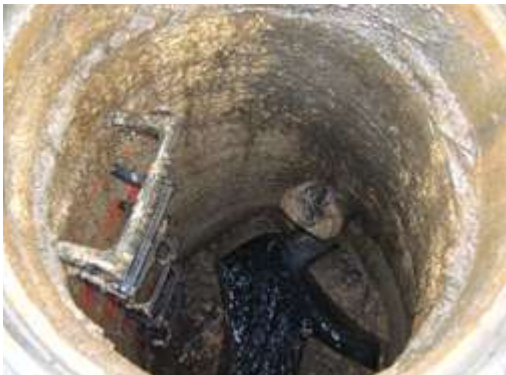
Defect

☒ **Leaks**

Infiltration: ☐ None ☒ **Joint** ☐ Cracks ☐ Mortar ☐ Roots ☒ **Wall**

Frame leaks. Adjustment infiltration.

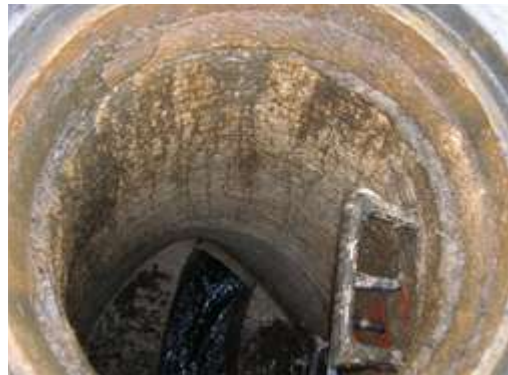
Defect

Frame leaks. Adjustmet infiltration - other side.

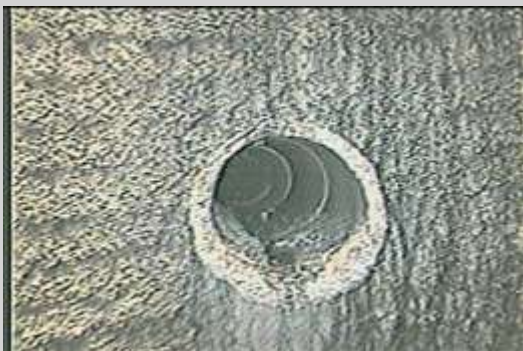
8 in. Circular Gravity Sewer Pipe In @ 1 O'Clock

Deposits: ☐ None ☐ Mud ☐ Sludge ☒ Debris ☐ Grease

Silt Depth: **0** (in.) Deposits Extent: **Light**

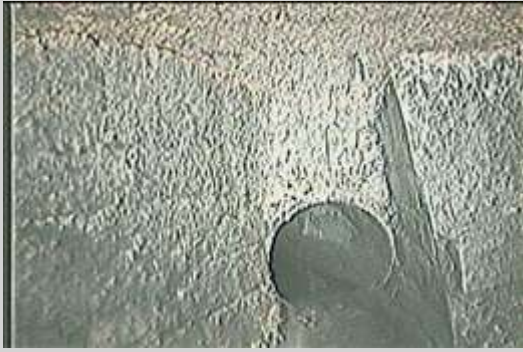
Pipe In @ 4 O'Clock

Deposits: ☐ None ☐ Mud ☐ Sludge ☐ Debris ☒ Grease

Silt Depth: **0** (in.) Deposits Extent: **Light**

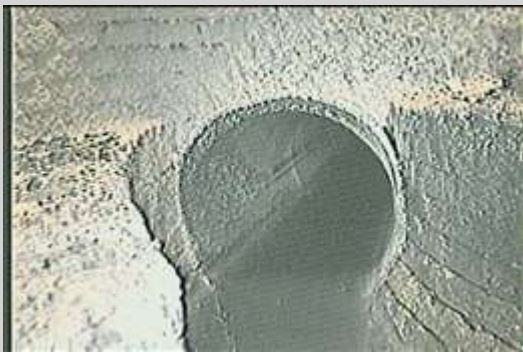
Pipe In @ 8 O'Clock

Condition: ☐ Sound ☐ Cracked ☐ Root Intrusion ☒ **Deteriorated** ☐ Leaks ☐ Debris

Channel deterioration.
